CAAD AND HISTORICAL BUILDINGS : THE IMPORTANCE OF THE SIMULATION OF THE HISTORICAL PROCESS

Santiago Sanchez, Alberto Zulueta & Javier Barrallo

The University of the Basque Country

KEYWORDS: Heritage Buildings, Historical Simulation, Hondarribia City Walls

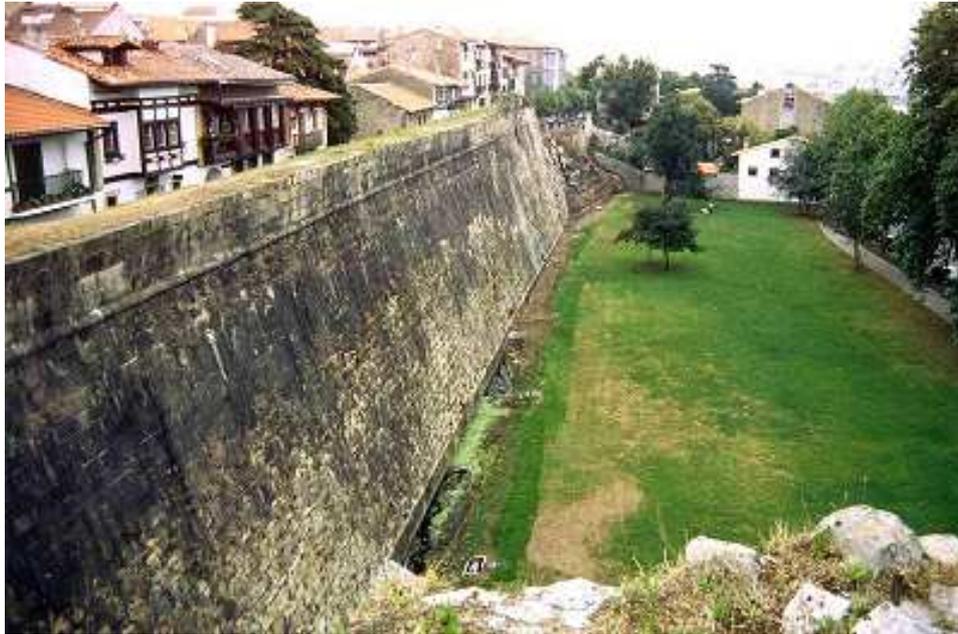
- Shells or bombs impacts that have destroyed the ashlar masonry or seated block of stone
- Damage from the exploding mines made by the French army. As a mine consist of an explosive charge situated under or near the foundations, many large cavities belonging to non used explosive mines are still drilled into the walls.

- The degradation of the masonry construction and the stone facing. The inner part of the Wall is a lime mortar masonry, soluble in water and resulting in calcium carbonate. The stone facing suffers surface erosion and decay of material.

- As the level of the inner streets is lower, the drainage and other infrastructures have to breach the Walls to reach the outside. This infrastructure has been destructive and inadequate.

- Due to the city's position, river water is present in the walls foundations as rising damp. The water goes up by capillarity action worsening the degree of chemical and biological attack.

- The city walls themselves retain a huge amount of rain water having a double effect: one is mechanical, due to the load of water. The other is adds to deterioration due to biological and chemical attack.

- Plants and small trees inhabit spaces between the ashlar blocks. The roots even dislodge the stone masonry.
 - The use by people have been unresponsive. The inhabitants of Hondarribia have built over the city walls, filling them with soil in order to cultivate covering of vaults and domes of the strongholds, and finally, they have used the walls as a quarry to obtain stones to build their houses.

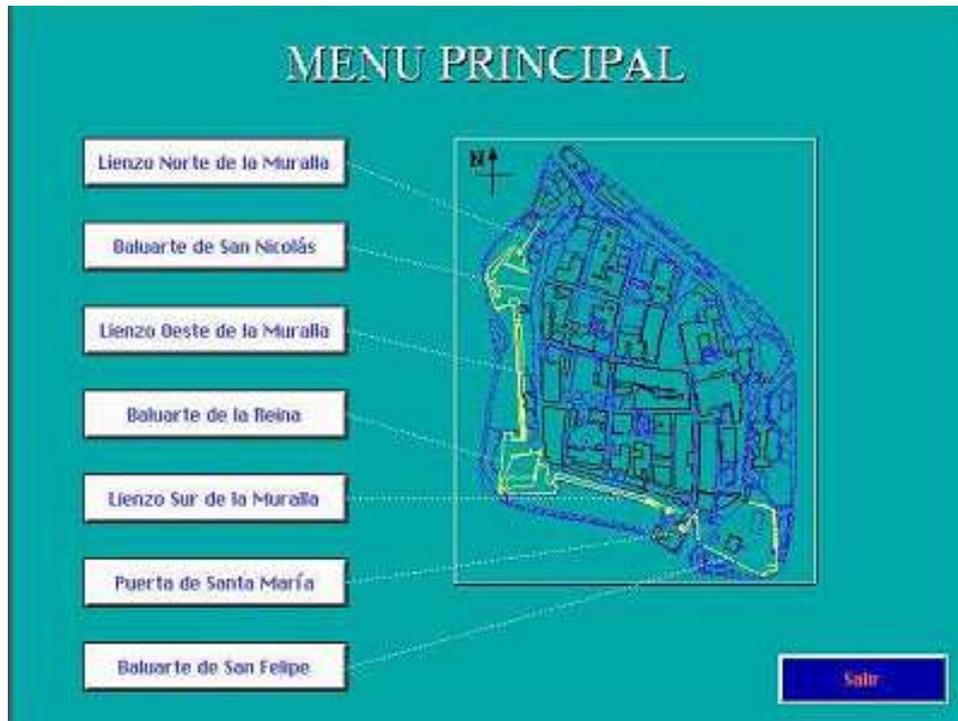
All the different parts of work can be reached easily by means of a hierarchical menu that allows a simple mouse navigation through the different items. The main screen shows three possibilities to start the course:

- Photographic Library. Shows a complete photographic journey along the city walls and a detailed catalogue of damages.
- Ancient Documents. Includes historical plans, ancient engravings, old documents and early photographs of the city walls.
- Experimental Works. Here are related stress measurement, finite element method simulation, terrain analysis, crack measurement and topographic detailed survey.

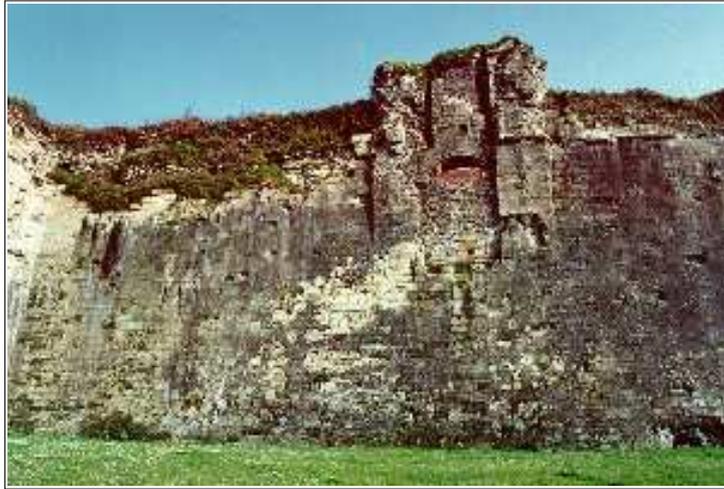
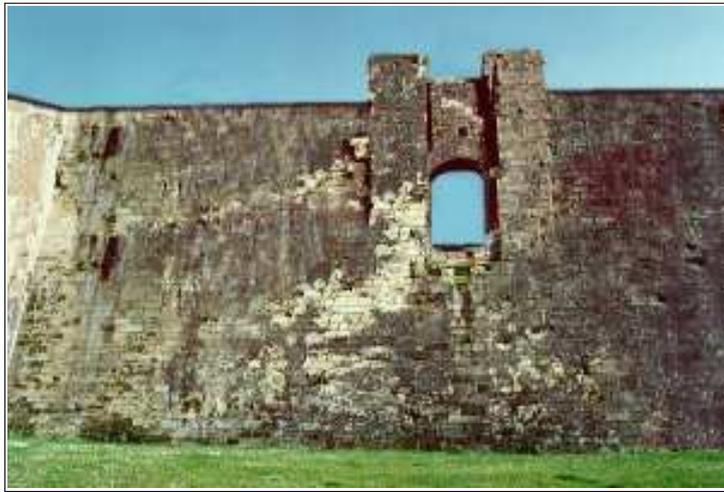
Thus, the damage of the city walls can be easily connected with historical information concerned with the warlike events that Hondarribia suffered in the wars with France. Photographs of the actual state can be compared with photographs of the beginning of the century. Ancient plans can be superimposed with new ones to determine modifications made on the Walls. Crack measurements can be compared with experimental and theoretical stress analysis. Another advantage of the system is the chance to include realistic pictures of the effects of the restoration prior to its execution. Below, there is an example of the virtual restoration of the Puerta de San Nicolás.
